JTB00620NAS1

TECHNICAL BULLETIN

303-01: Engine

Engine MIL Illuminated With DTC P132B-77 Stored

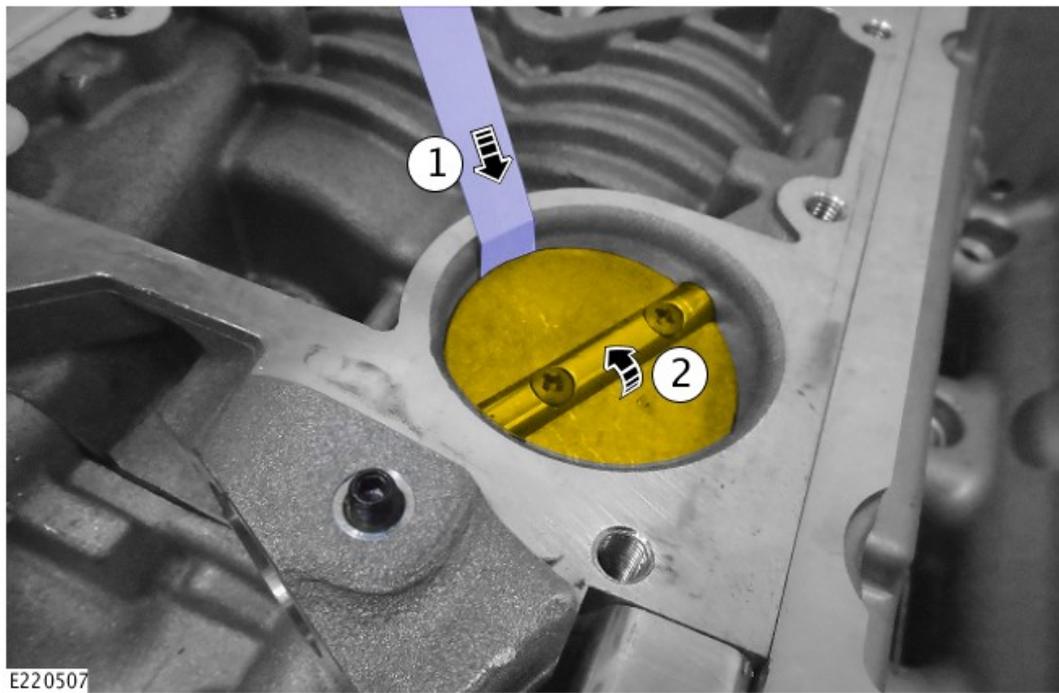
2.

With the bypass valve in an open position, insert a feeler gauge **(1)** of 0.102 mm (0.004") into the valve body and close the valve **(2)**.

- ■ If the bypass valve is **NOT** set to a gap of 0.102 mm (0.004"), **continue to Step 3.**
 - ■ If the bypass valve is set to a gap of 0.102 mm (0.004"), **refer to TOPIx Workshop Manual section 303-14A-E [depending on model]: Electronic Engine Controls - Diagnosis and Testing and continue with diagnosis of DTC P132B-77 as a separate claim.**
-
