LTB01156NAS2

TECHNICAL BULLETIN

303-01: Engine

Engine MIL Illuminated With DTC P132B-77 Stored

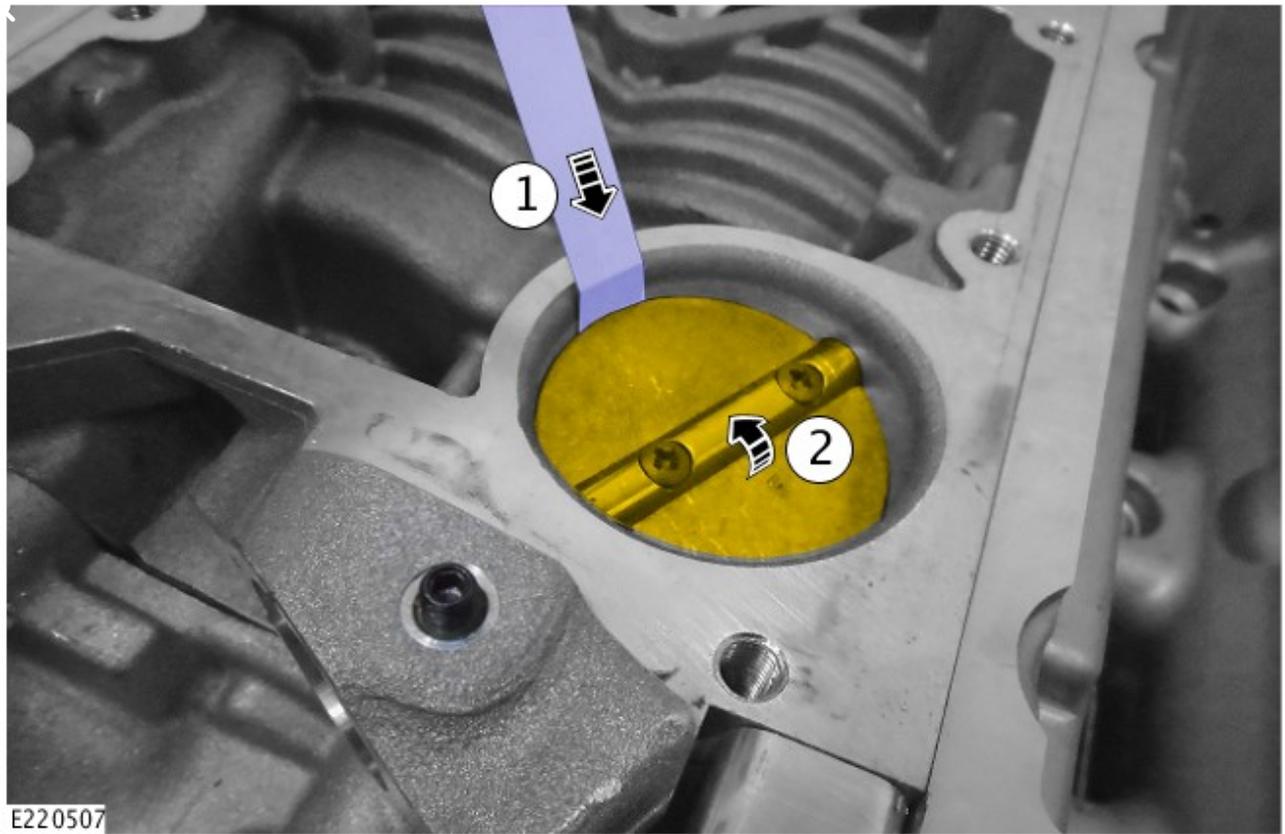
With the bypass valve in an open position, insert a feeler gauge **(1)** of 0.102 mm (0.004 in) into the valve body and close the valve **(2)**.

- If the bypass valve is **NOT** set to a gap of 0.102 mm (0.004 in), **go to Step 3**.
- If the bypass valve is set to a gap of 0.102 mm (0.004 in), **refer to TOPIx Workshop Manual section 303-14A-E [depending on model]: Electronic Engine Controls - Diagnosis and Testing and continue with diagnosis of DTC P132B-77 as a separate claim.**
